Contract #: 04-0120F4Cty: SF/ALA Rte: 80 PM: 13.2/13.9File #: 69.28**WELDING INSPECTION REPORT****Resident Engineer:**Pursell, Gary**Address:** 333 Burma Road**City:** Oakland, CA 94607**Report No:** WIR-014170**Date Inspected:** 12-May-2010**Project Name:** SAS Superstructure**OSM Arrival Time:** 700**Prime Contractor:** American Bridge/Fluor Enterprises, a JV**OSM Departure Time:** 1900**Contractor:** Zhenhua Port Machinery Company, Ltd (ZPMC), Changxing Island **Location:** Shanghai, China**CWI Name:** Zhao Chen Sun**CWI Present:** Yes No**Inspected CWI report:** Yes No N/A**Rod Oven in Use:** Yes No N/A**Electrode to specification:** Yes No N/A**Weld Procedures Followed:** Yes No N/A**Qualified Welders:** Yes No N/A**Verified Joint Fit-up:** Yes No N/A**Approved Drawings:** Yes No N/A**Approved WPS:** Yes No N/A**Delayed / Cancelled:** Yes No N/A**Bridge No:** 34-0006**Component:** Tower Components**Summary of Items Observed:**

WELDING INSPECTION REPORT

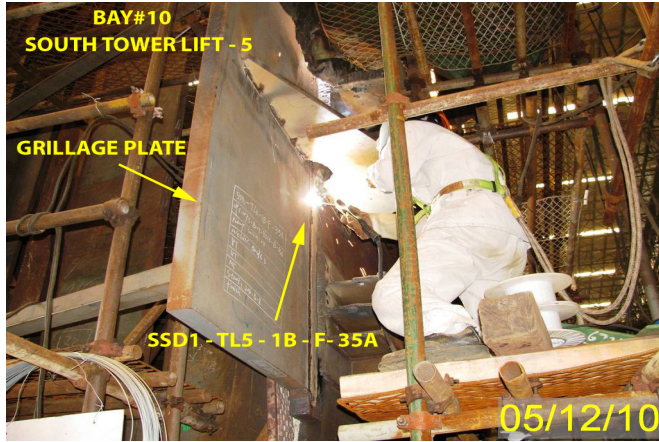
Weld joint # 35A located on South Tower Lift – 5 SSD1 – TL5 – 1B – F. Welder is identified as 500363. ZPMC Quality Control (QC) Inspector is identified as Deng Zhi Bing. The welding variables recorded by QC appeared to comply with the WPS – B – T – 3213 – B – U3b. (See attached photo)

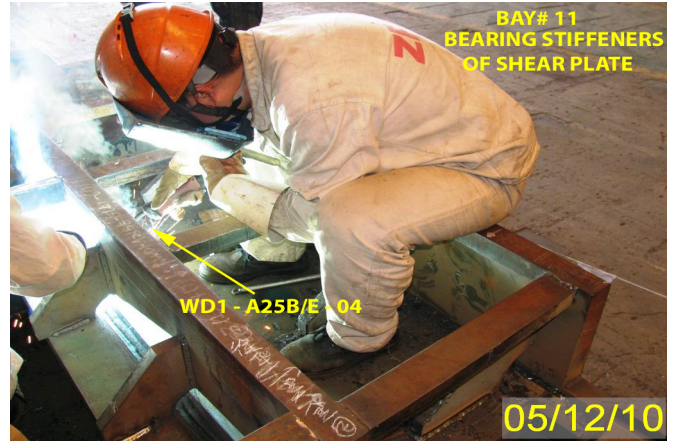
Weld joint # 04 located on Bearing Stiffener of Shear plate WD1 – A25B/E. Welder is identified as 049541. ZPMC Quality Control (QC) Inspector is identified as Shang Hai Long. The welding variables recorded by QC appeared to comply with the WPS – B – T – 2331 – Tc – P4 – F. (See attached photo)
